Coal Mine Fatal Accident 2003-16

Operator:	Mountain Spring Coal Company
Mine:	#1 Mine
Accident Date:	June 13, 2003
Classification:	Electrical
Location:	District 2, Beaver Co., Pennsylvania
Mine Type:	Underground
Employment:	32
Production	1,400 tons/day prior to being placed in BA Status on 6/11/03

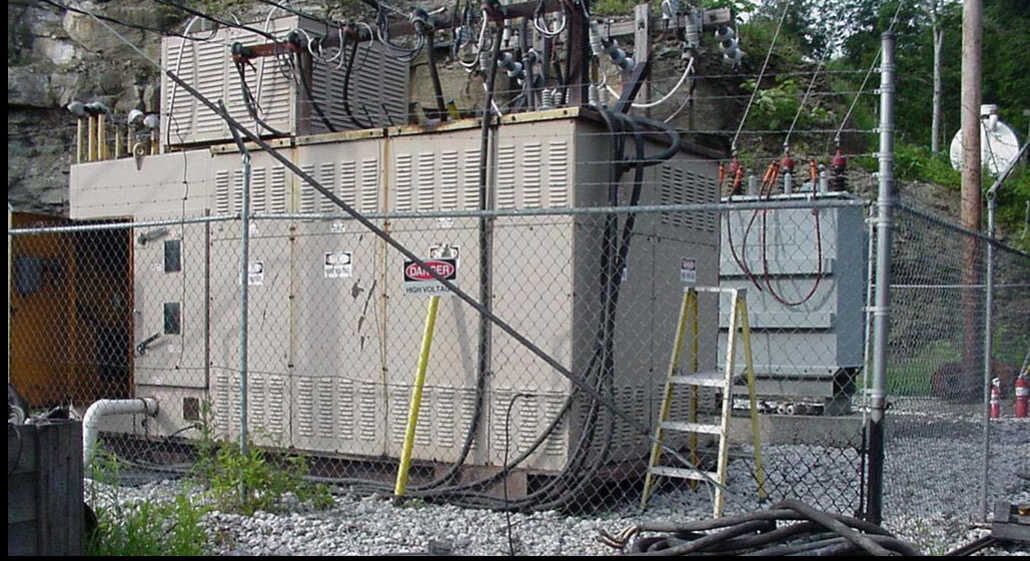
- In November of 2001, an independent contractor recommended that a capacitor bank be installed at the substation to improve the mine power factor.
- Mine personnel, including the victim, installed a capacitor bank on the roof of the enclosed unit.
- The capacitor bank was not secured to the roof.
- Because of the location of the capacitor bank disconnects, the capacitor bank had to be pushed forward 6 to 8 inches to allow removal of the fuse from the center disconnect.
- The victim used the hotstick to open the fused disconnects for the capacitor bank, but not to close them. This put him in close proximity to live unguarded parts.

- *Causal Factor:* The location of the capacitor bank and capacitor disconnects required the victim to be exposed to unguarded live parts .
- *Corrective Action:* When and if the capacitor bank is reinstalled it will be completed in accordance with the National Electrical Code. The use of hotsticks shall be discussed in the retraining of qualified electrical personnel.

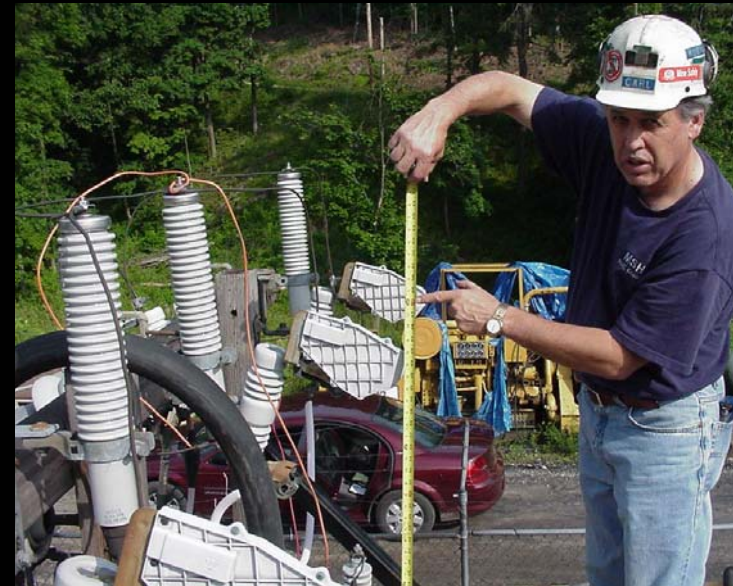
- 104(d) (1) Order for a violation of 30 CFR 77.516.
 - The high voltage capacitors installed on the roof of the enclosed unit in the surface substation did not comply with the provisions of the 1968 National Electric Code.
 - Article 710-34 (f) of the NEC states "Unguarded live parts above working space shall be maintained at elevations not less than required by the following table: Table 710-34 (f) Voltage between phases 11001 – 22000, Minimum Vertical Clearance of Unguarded Parts 9 foot 3 inches".
 - The high voltage capacitor disconnect switches were mounted 44 inches above the roof of the enclosed unit.
 - The capacitor bank and terminals were located below the disconnects.
